WL-TR-96-4015

CERAMIC BEARING DEVELOPMENT

VOL 1, FATIGUE AND WEAR BEHAVIOR OF NBD-200
SILICON NITRIDE BALLS

MARCH 1995

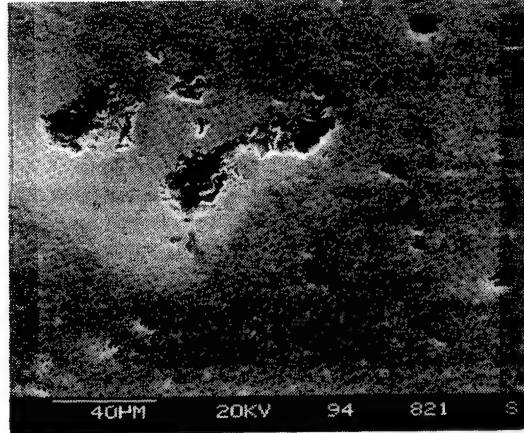
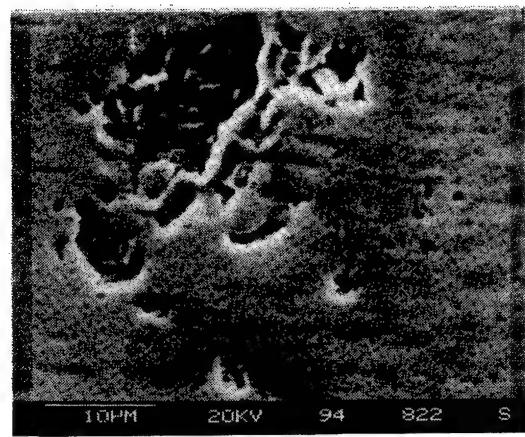
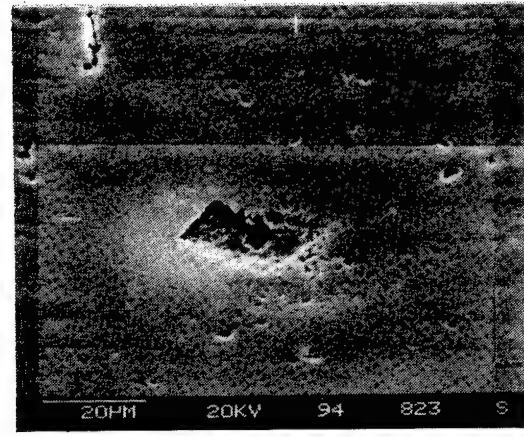
Figures 55 and 56 show, respectively, the post-test appearance of the outer and inner races. Both are marked by numerous microspalls. Note that the race finishes, away from

the spalls, appear much smoother in the all-steel bearing than those in the hybrid bearing illustrated in Figures 48 and 49. The reason for this is not clear. It could be related to some mutual plastic accommodation of the ball and race surfaces or, simply to a greater degree of polishing due to more debris passing through the all-steel bearing in the presence of a greater number of microspalls. At any rate, the effect is minor, in terms of the volume of material removed, compared to that associated with the microspalling.

Figure 55 Post-Test Appearance of M-50 Outer Race, Bearing X1,
Run 500 Hrs., At 2.27 GPa (329 ksi), $\lambda=0.3$: (a)
General Appearance, (b,c,d) Microspalling.

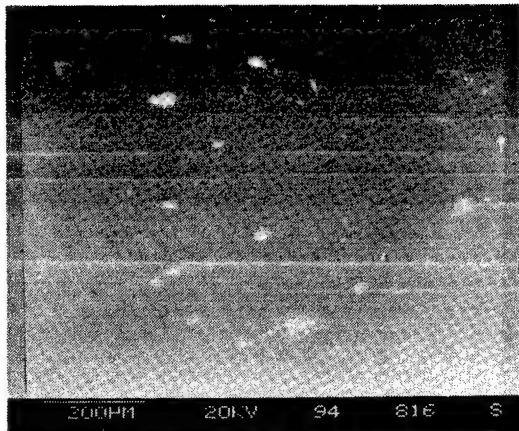
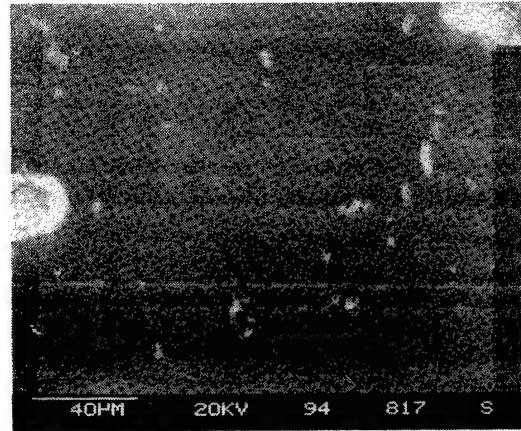
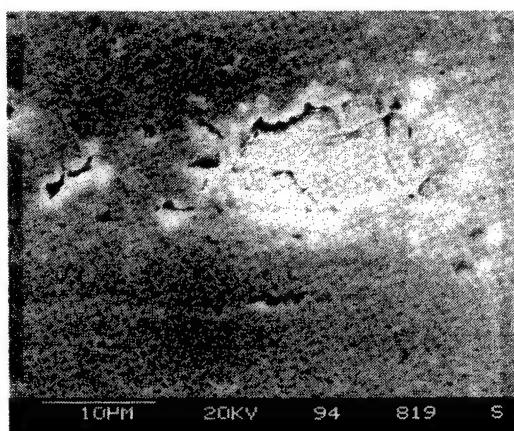
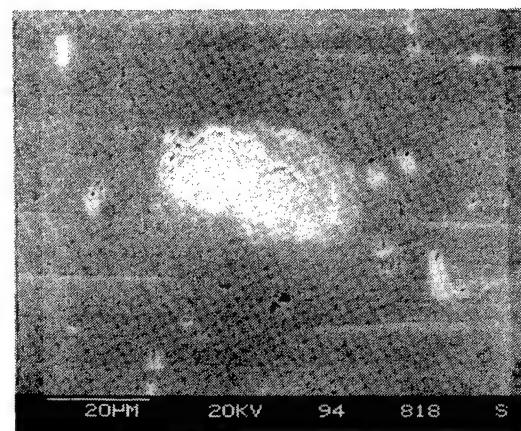
Figure 56 Post-Test Appearance Of Inner Race Of All-Steel Bearing M-50-X1 Run 500 Hrs. At 2.27 GPa (329 ksi)
 $\lambda = 0.3$ (a) General Appearance (b,c,d)
Microspalling.

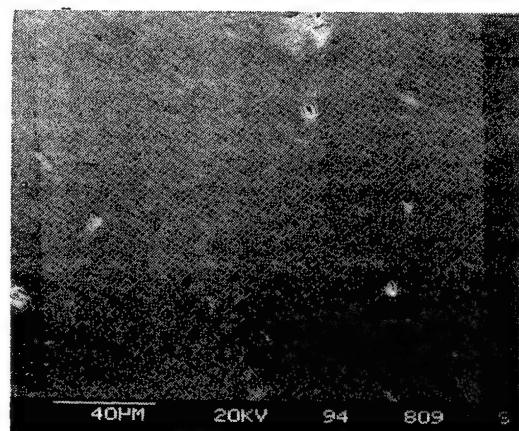
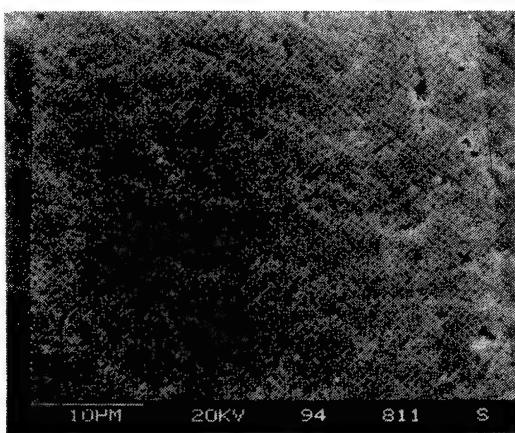
Figure 57 shows the appearance of the M-50 steel balls after testing. Significant amounts of microspalling occurred on the balls as well as on the races. The unspalled ball surface, also, was smoother than before testing as seen by comparison with Figure 53.

Figure 57 Post-Test Appearance Of M-50 Balls From Bearing
M-50-X1 Run 500 Hrs. At 2.27 GPa (329 ksi) $\lambda = 0.3$:
(a) Outside Wear Track Showing Minor Debris Denting,
(b) In Wear Track Showing Microspalls, (c) In Wear
Track, Smoothing Of Surface Finish, (d)
Microspalling.

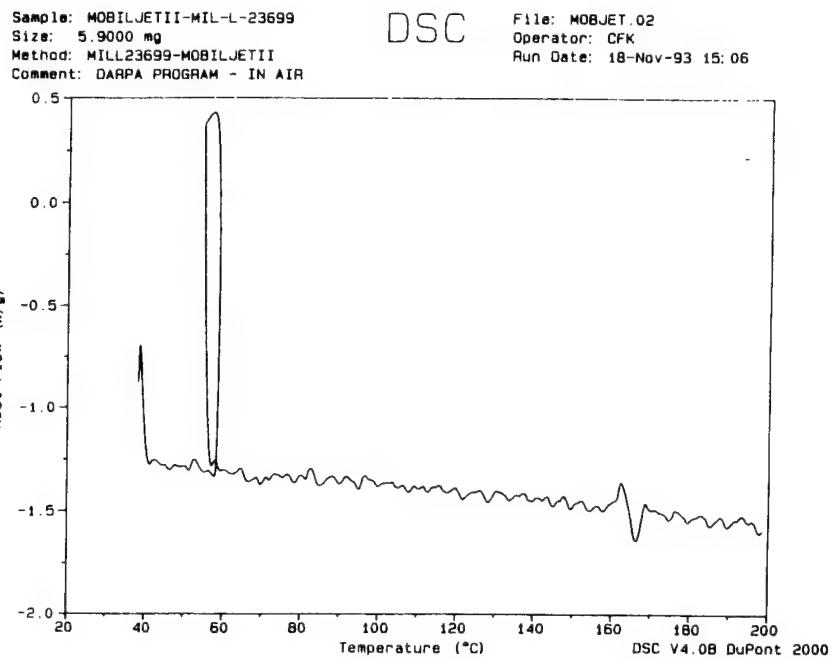
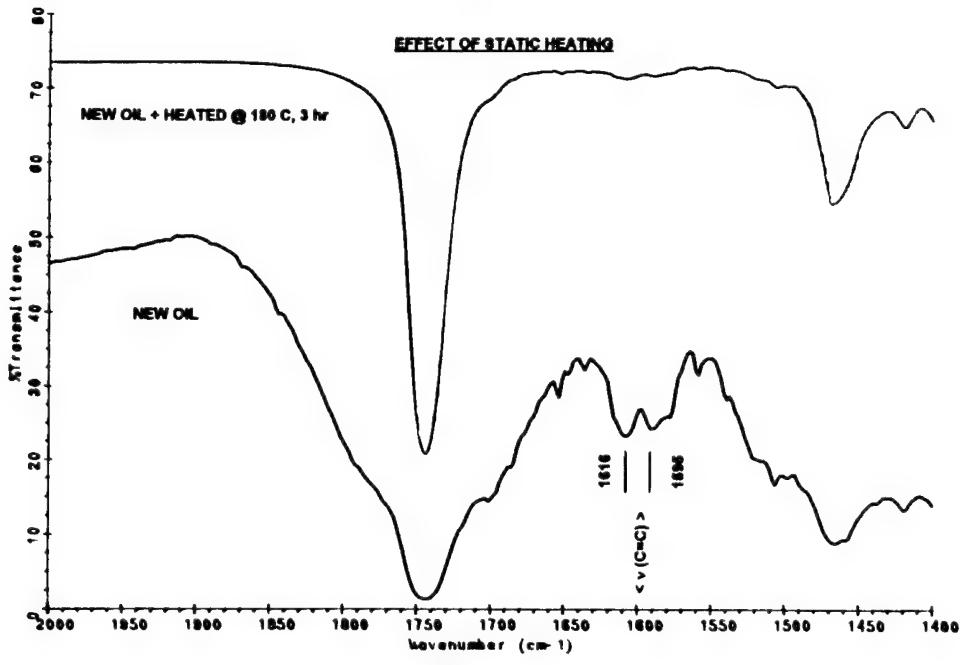
As shown in Figure 59a, a reaction occurred at 164.5°C (328°F). Based on this information, a sample of the oil was heated to 180°C (356°F) for a period of 3 hours. The FT-IR analysis of this sample showed (Fig. 59b) that decomposition of the phenyl ring $\langle v(C=C) \rangle$ bond had occurred, which appeared at wavenumbers 1595 and 1616 cm^{-1} in the new oil. No other changes were evident.

Figure 59 (a) DSC Scan Of New MobilJet-II Lubricant, Reaction At 164.5° C., (b) FT-IR Comparison Of MobilJet-II Heated 3 Hr. At 180° C., (With Unused Oil. Decomposition Of ν (C = C) Bond At 1595 And 1616 cm^{-1}).

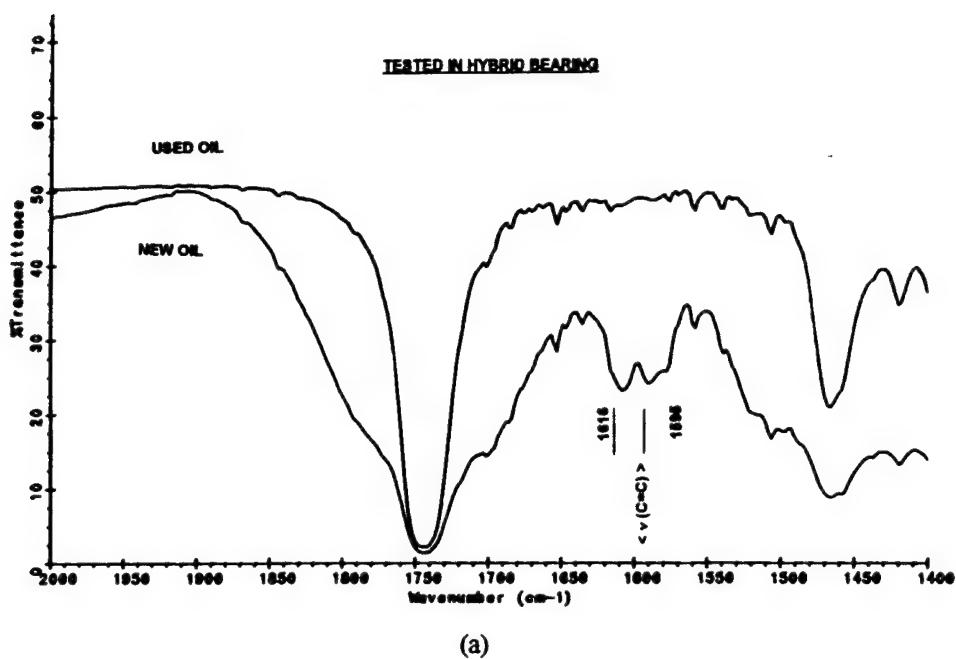
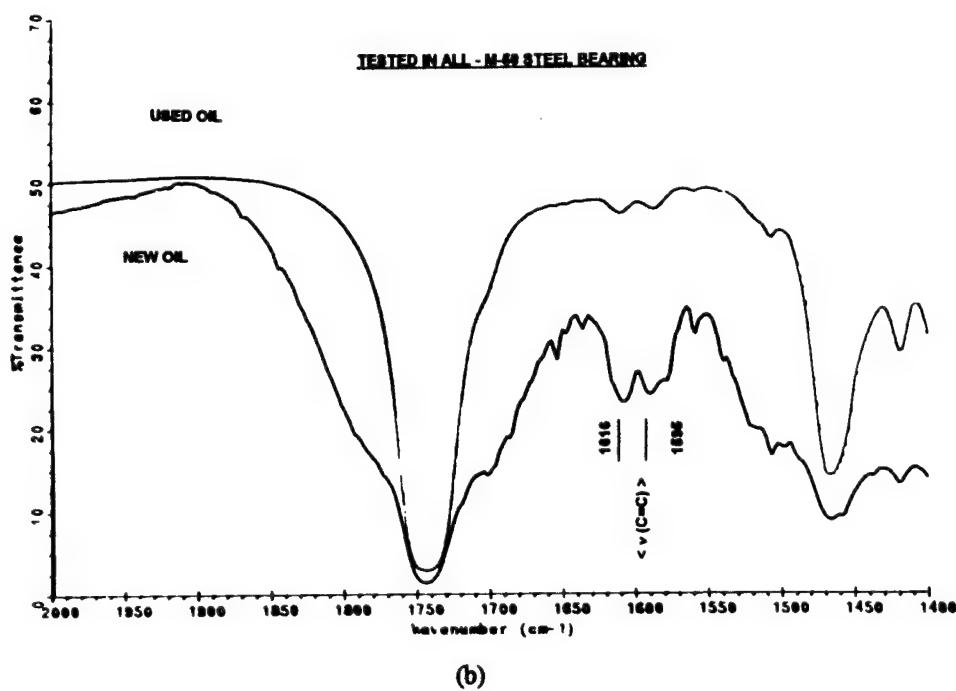
The FT-IR spectra of samples of lubricant from the wear tests of the hybrid M-50 steel bearing "B-3" and the all-M-50 steel bearing "X1" are shown in Figure 60. The unexpected, and unexplained, result is shown (Fig. 60a) that the same $\langle v(C=C) \rangle$ bond decomposition occurred in the test of the hybrid bearing at a temperature of only 121°C (250°F) when the influence of the dynamic rolling contact was added. In the lubricant from the all-steel bearing test, however, the phenyl ring $\langle v(C=C) \rangle$ bond is still present after running. This observation bears further investigation, since lubricant stability is usually considered to be improved in hybrid bearings, as compared to all-steel bearings. It is possible, based on the measured relatively smoother race finishes of the post-tested, all-M-50 steel bearings, that the contact temperatures were actually lower in this bearing than in the hybrid bearing. The shorter operating time and the lower actual contact stress in the all-steel bearing are, of course, alternative explanations.

Figure 60 FT-IR Comparison Of Used And Unused MobilJet-II Oils
 Tested At 121° C (250° F) In: (a) M-50-B3 Hybrid
 Bearing 830 Hr., (b) M-50-X1 All-Steel Bearing 500
 Hr.
